# **CFD Modeling & Verification** in an Aircraft Paint Hangar

Airflow Rates and OSH&E Protection

E2S2 May 9-12, 2011

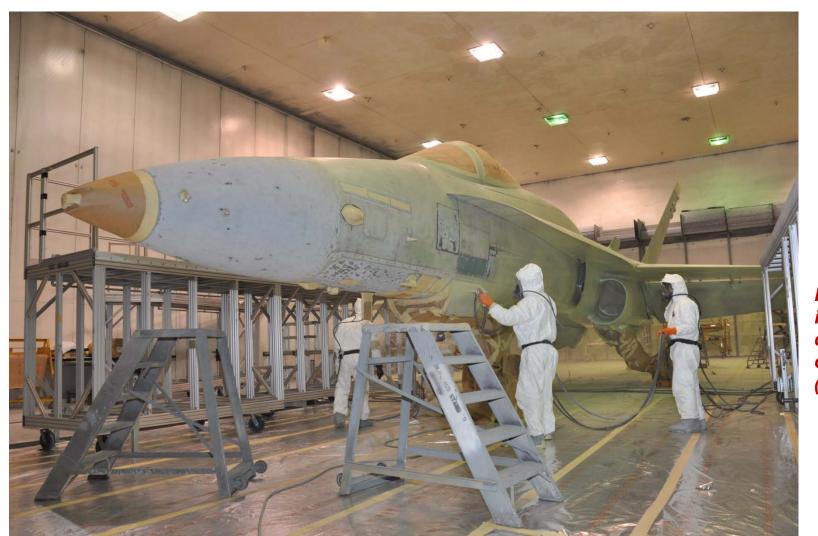
## October 2010 Painting Operations

Hoseman is often downwind of sprayer (source)
